January 19, 2016

Re: Structural Inspection Report  
521 Livingston Street  
Norwood, NJ 07648  
MC Project No. 16000141A

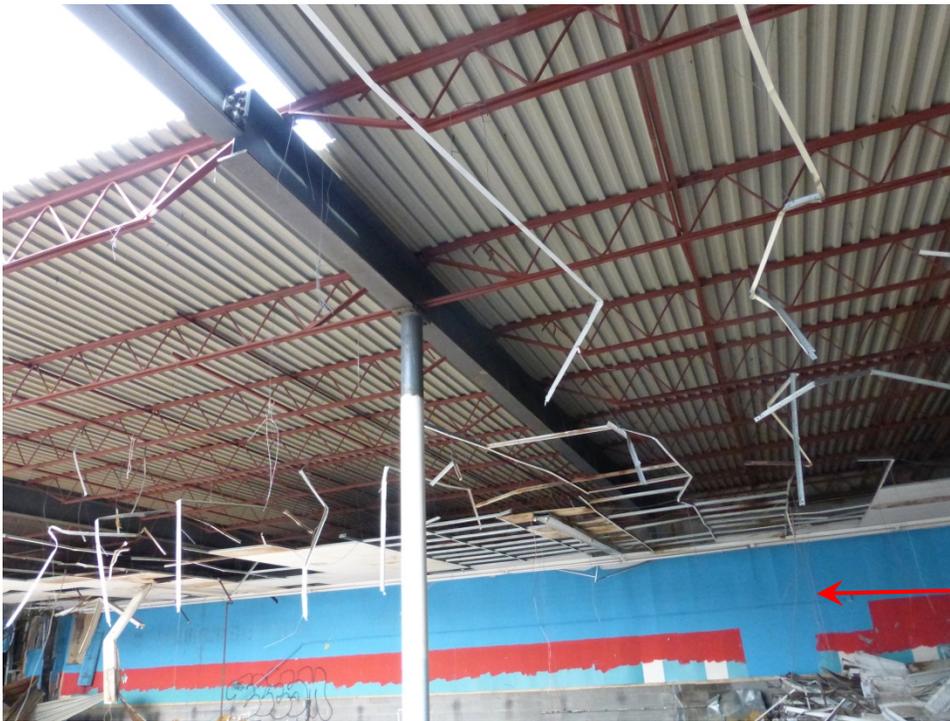
1. The roof framing consists of steel bar joists and beams (see photograph 1).
2. The steel beams run into the separation wall between the abandoned building and the rest of the strip mall.
3. The steel beams are supported by columns within the separation wall (see photograph 2).
4. The demolished portion of the roof has left all of the interior framing exposed to the elements (see photograph 3).
5. Removing a large portion of the framing has left the back wall and two rows of columns laterally unbraced (see photograph 3).

Photograph 1 – Abandoned Building, Roof Framing

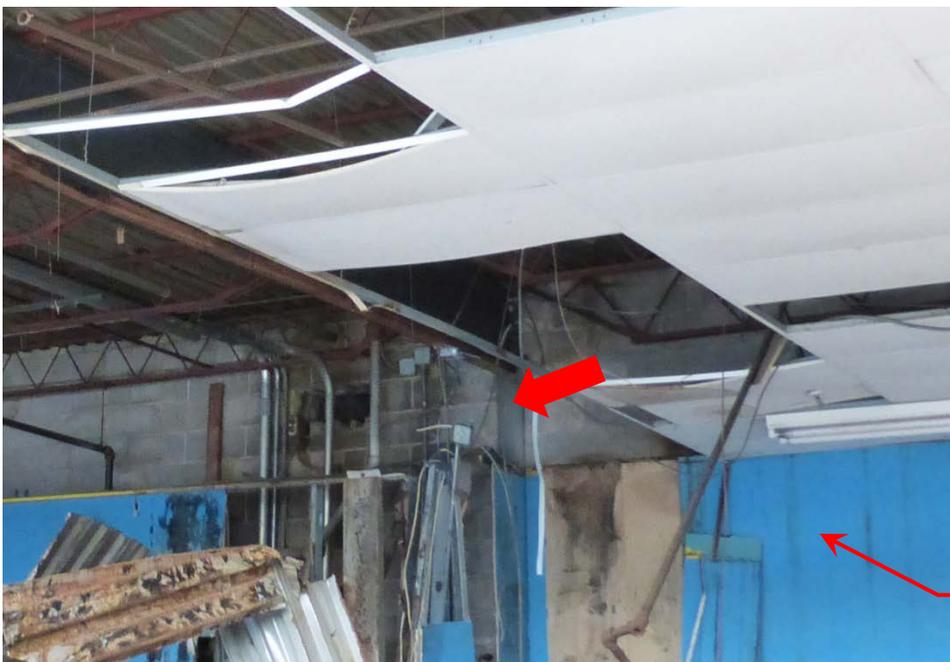
Photograph 2 – Column in Separation Wall

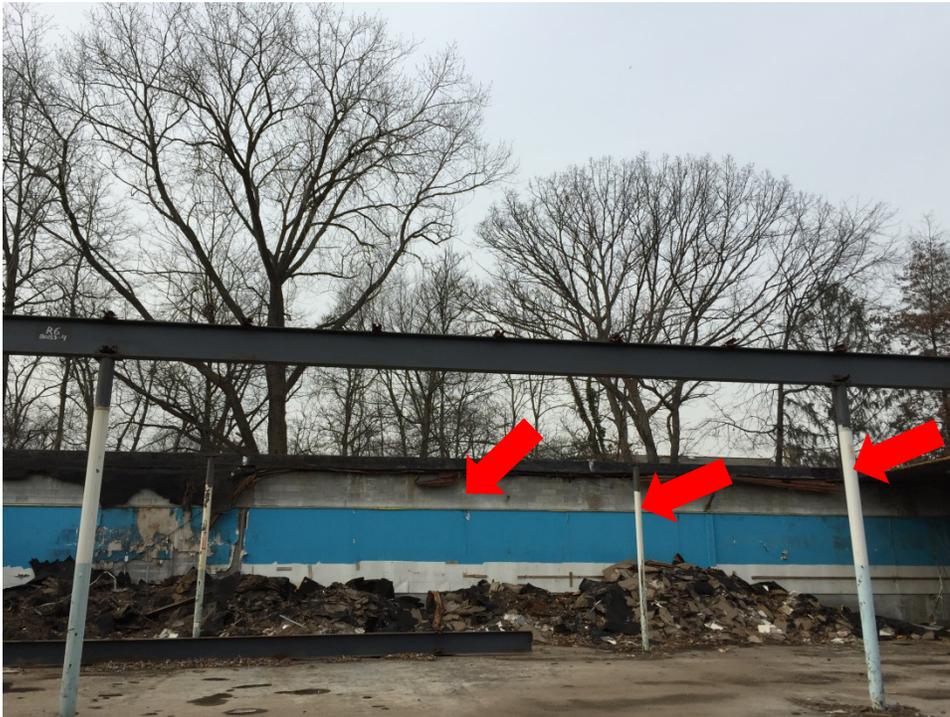
Leaving the back wall and multiple columns unbraced presents unsafe conditions inside and outside of the abandoned building. Although the back alleyway is blocked off, it is still accessible and the unbraced wall presents a safety concern for anyone around the building if it were to collapse due to a wind gust.

Since the roof is now open, many of the steel members are now exposed to the elements. This can lead to deterioration of the steel elements and weakening of the abandoned building's framing. Additionally, the remaining interior members are now exposed to the wind loads, which they were not originally designed for.

Photograph 3 – Unbraced Back Wall and Two Rows of Columns

Therefore, we recommend immediate demolition of the entire abandoned building. Due to the fact that the abandoned building shares a common wall with the strip mall, the demolition would now compromise the structural integrity of the strip mall, thereby causing the need for the strip mall to be demolished also.

Based on all of the above-referenced observations, the current site as it exists poses an unsafe condition to both the businesses operating on the site and the patrons using those businesses. We recommend closing this site immediately to public access.

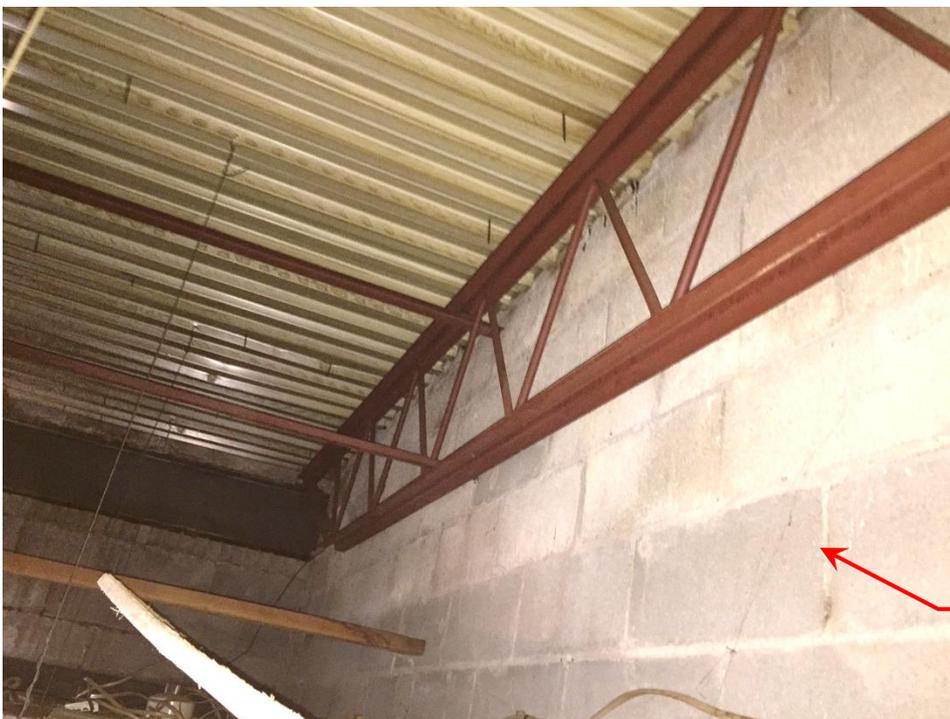
6. The framing of the rest of the strip mall consists of steel bar joists and beams (see photograph 4).
7. The framing of the active strip mall is lower and separate from the framing of the abandoned building with the exception of the common wall between both structures (see photograph 4 & 5).

Photograph 4 – Strip Mall, Roof Framing

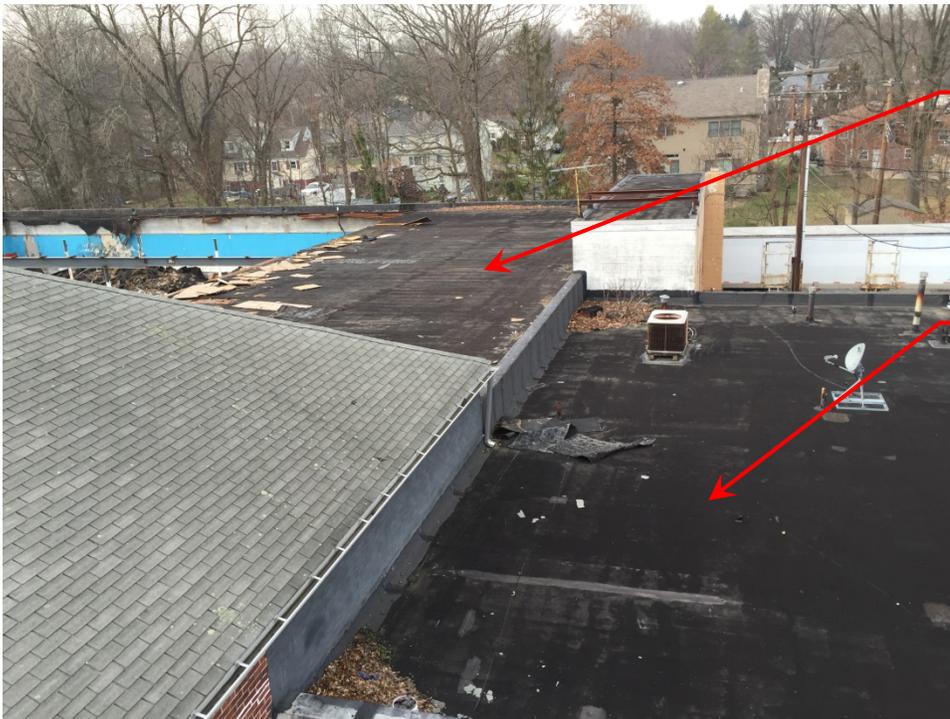
Please note that demolition of the framing, embedded into the separation wall, (between both buildings) i.e. beam ends and columns, will affect the framing of the active strip mall. It is the opinion of this office that this disturbance of the common wall may trigger the need for partial demolition of the active strip mall structure. It is also the opinion of this office that trying to investigate, brace and stabilize the common wall along with the partial demolition and reconstruction of the active strip mall structure, adjacent to the common wall, would be cost-prohibitive.

Photograph 5 – General View of Roof
